National Transportation Safety Board

WPR20LA283

AIRWORTHINESS

Group Chair's Factual Report

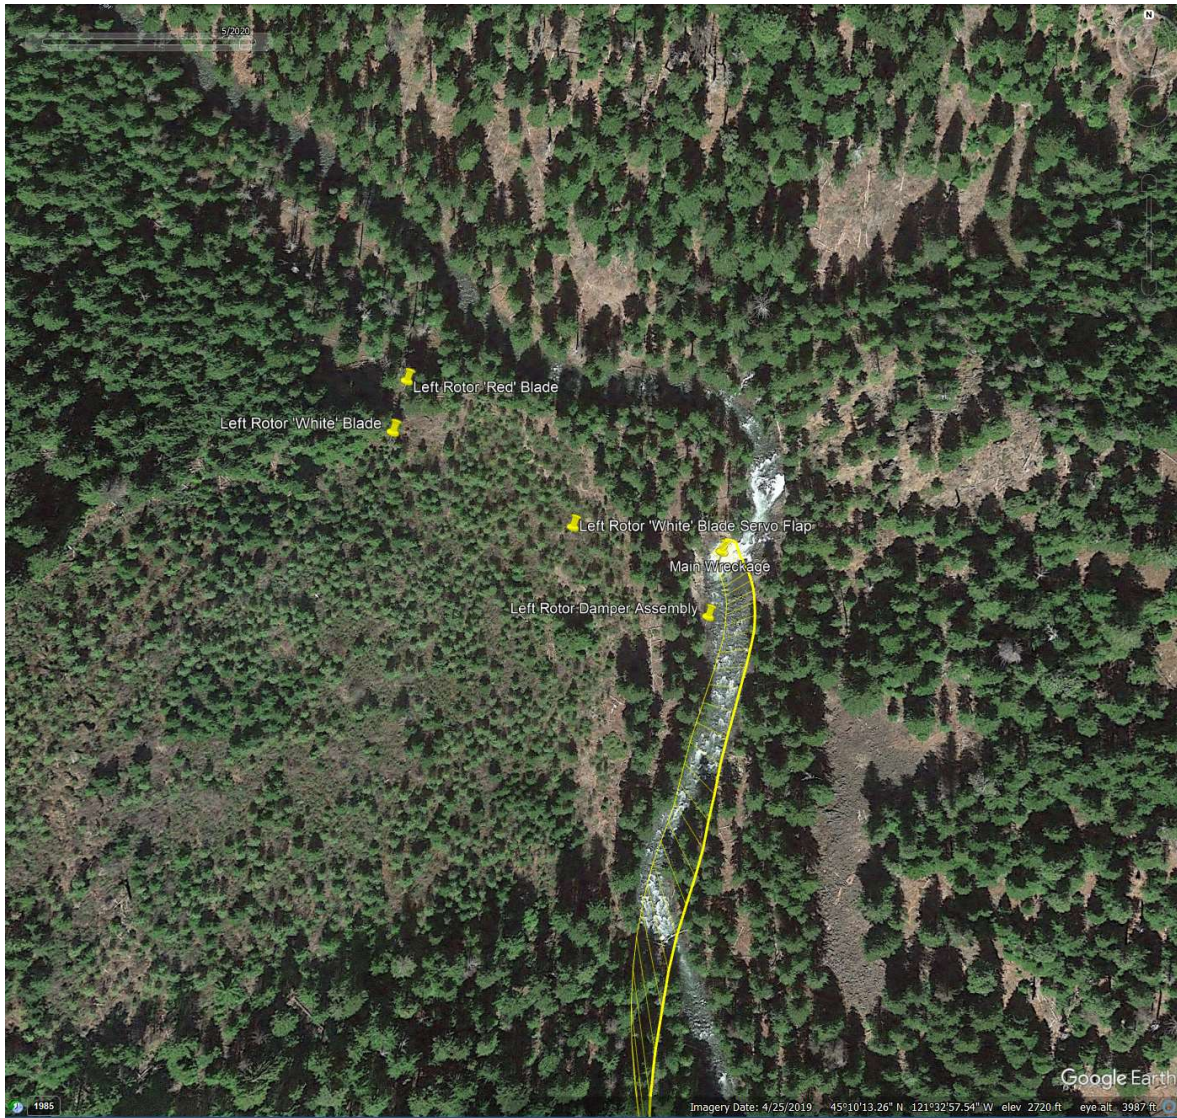
Figure A-1. The flight path (yellow line) and the approximate locations of various left rotor system pieces found around the accident site.

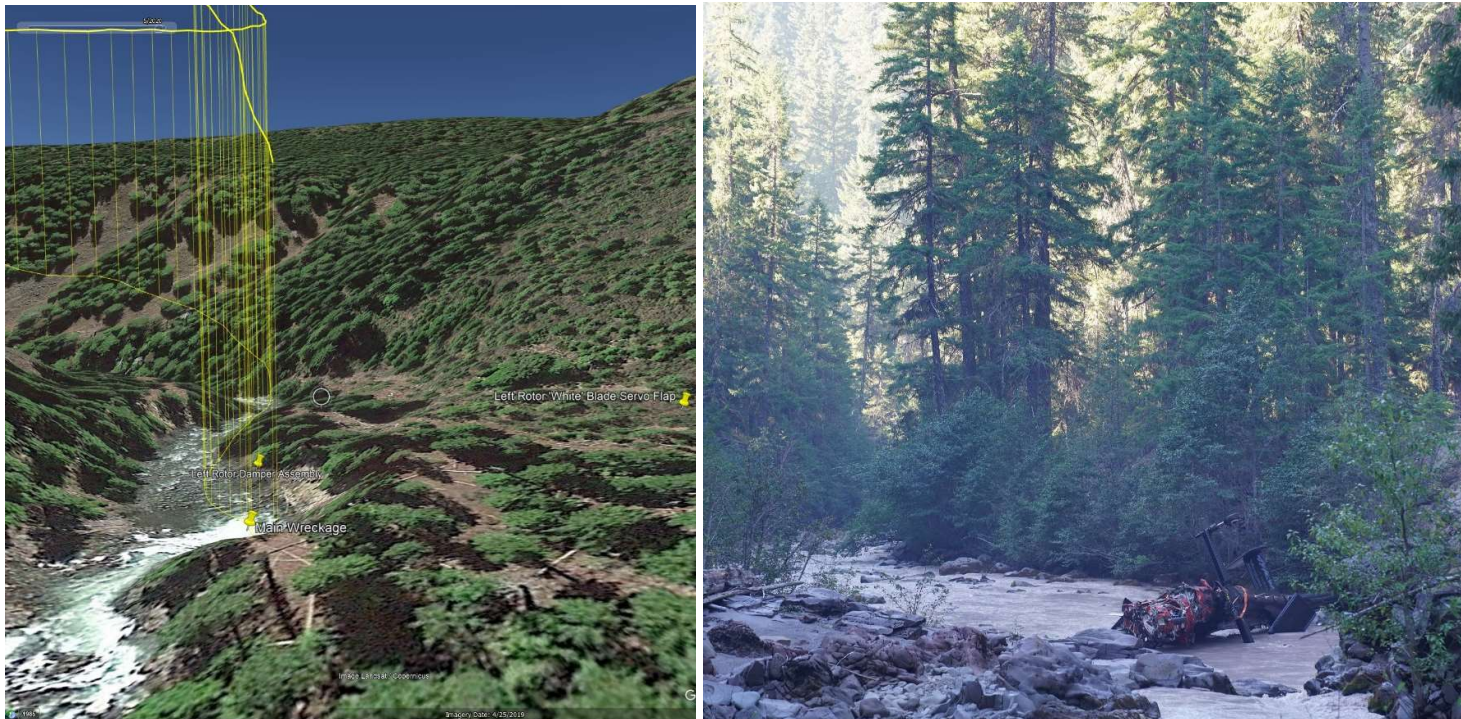
Figure A-2. A view of the flight path leading to the accident site (left) and a photo from the accident site in a similar direction to show the surrounding trees (right). (Image on the right provided by Central Copters.)

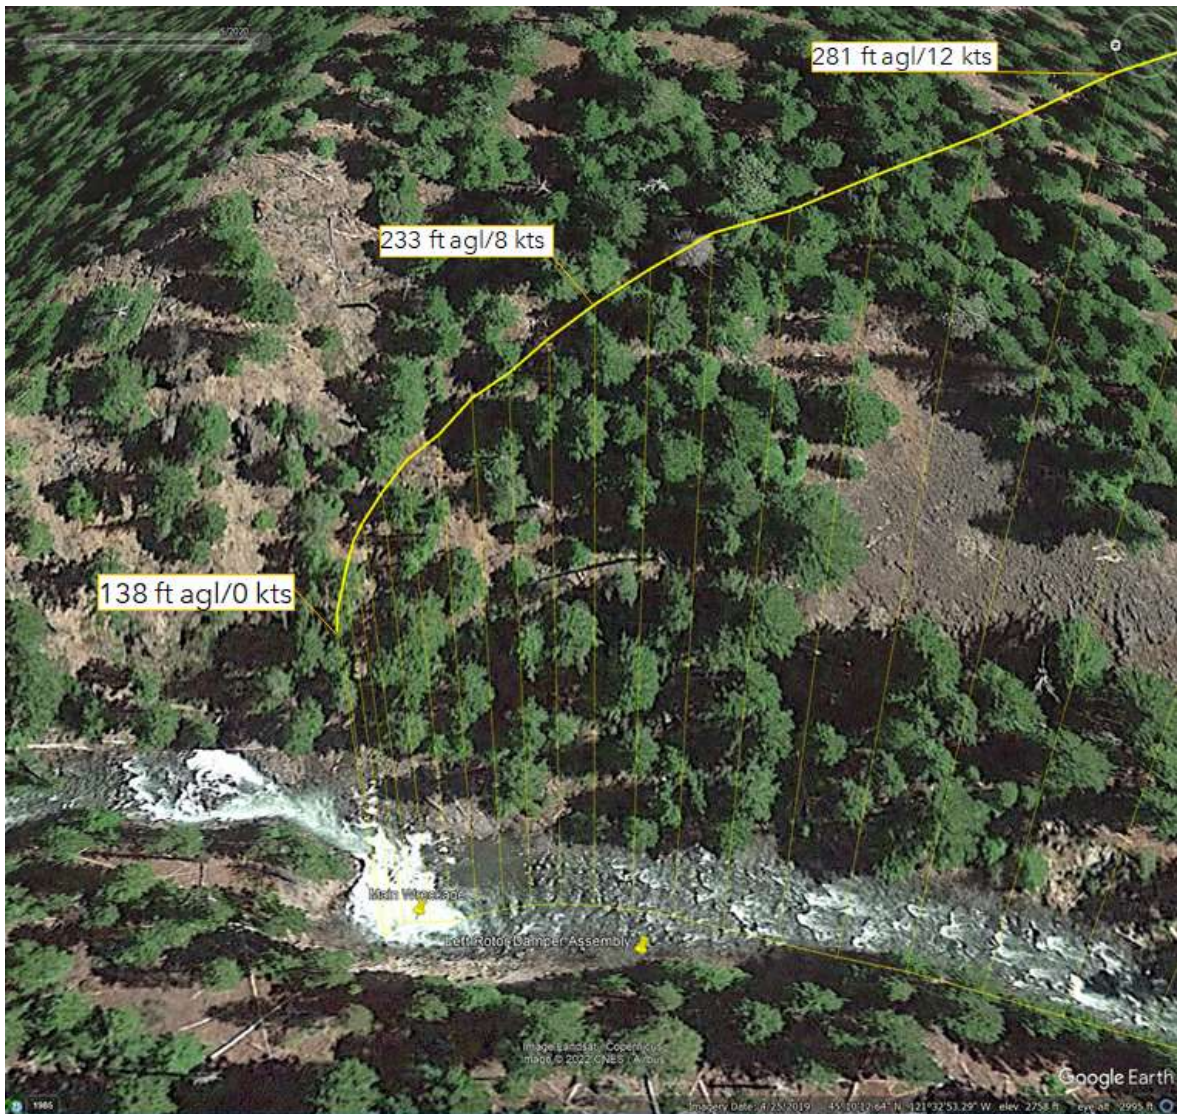
Figure A-3. The flight path showing height above ground and speed. The spacing of each vertical line of the flight path represents a 1-second interval.
